Intel® Celeron™ Processor Specification Update

Release Date: December 1998

Order Number: 243748-010

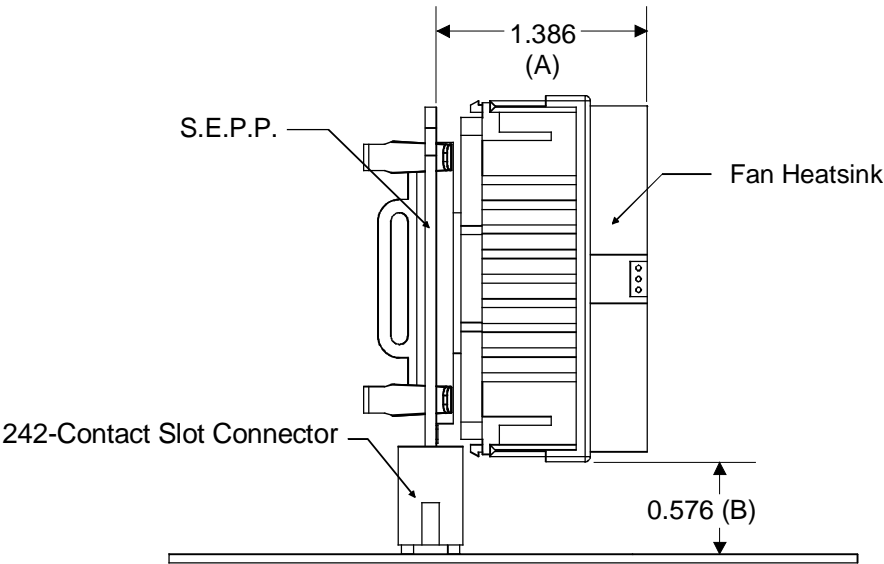
Figure 20. Side View Space Requirements for the Boxed Processor

Figures 20, 21, and 22, and Table 34 of Section 6.2 of the *Intel Celeron Processor at 266 MHz, 300 MHz, 300A MHz, and 333 MHz Datasheet* show incorrect fan heat sink dimensions for the boxed Intel Celeron processor. The correct figures and table are shown below.

The maximum depth of the fan heat sink to the processor substrate should be 1.386", not 1.291" max. The minimum height clearance above the baseboard should be 0.576", not 0.485". The fan shroud height should be 2.02" and 4.74", respectively, not 2.19" max. and 4.90" max. Figure 22 should show reference "G" for the minimum airflow keepout zone from the inlet of the fan heat sink, and reference "F" for the minimum airflow keepout zone from the ends of the fan heat sink.
